RESPONSE OF STRUCTURAL SYSTEMS TO THE LUBBOCK STORM

FINAL REPORT

TEXAS TECH UNIVERSITY STORM RESEARCH REPORT 03
(TTU SRR 03)

October 1971

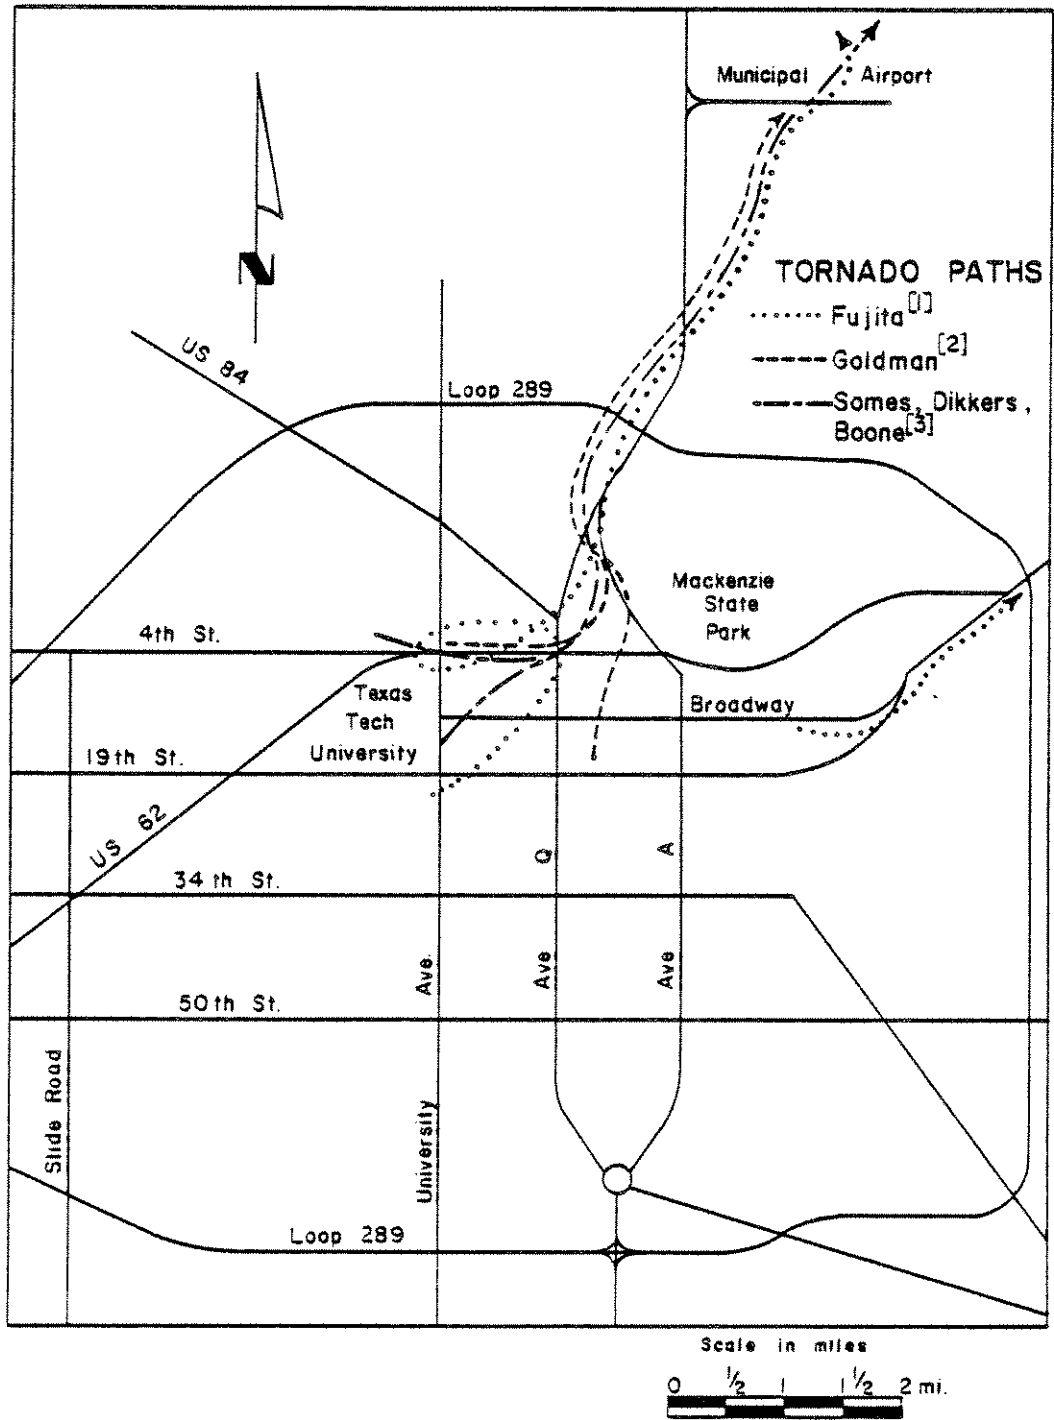
FIGURE 1. SUMMARY OF THREE THEORIES REGARDING THE CONFIGURATION AND PATH OF THE LUBBOCK STORM

of the two tornadoes are mapped in his article on the Lubbock Storm and in Figure 1. According to Fujita, a "first" tornado originated at about 8:10 p.m. at a point 3 mi east of the downtown area; he reports that this tornado moved northeastward to the city limits. According to a documentary report prepared by the Office of Civil Defense [2] there were no reports of a tornado at this time to the Emergency Operations Center (EOC) in City Hall. A communication from the Lubbock Weather Bureau to the EOC reflected a hook echo at approximately this location at about 9:03 p.m., although there was no visible confirmation of a tornado in this area from the police reporting system or from the public. The existence of this first tornado on the ground is questioned by the authors on the basis of analysis of damaged structures in this area (Section III, Structure 87). Fujita describes the path of the "second" tornado as originating south of Texas Tech University, making a loop between a point just west of 4th Street and Avenue Q and a point at the northeast corner of the University campus, and then travelling northeastward to the Lubbock Weather Bureau Station. This storm path is shown in Figure 1.

Goldman [3] describes the configuration of the storm by outlining a sequence of events that occurred between 9:35 p.m. and 10:06 p.m. on May 11. His theory includes the possible existence of three tornadoes (Ref. Fig. 1). He suggests a tornado "aloft" moving north-northeastward across the center of the downtown area "damaging tall buildings extensively but leaving shorter ones relatively untouched." A "second" tornado is described as originating northeast of the Texas

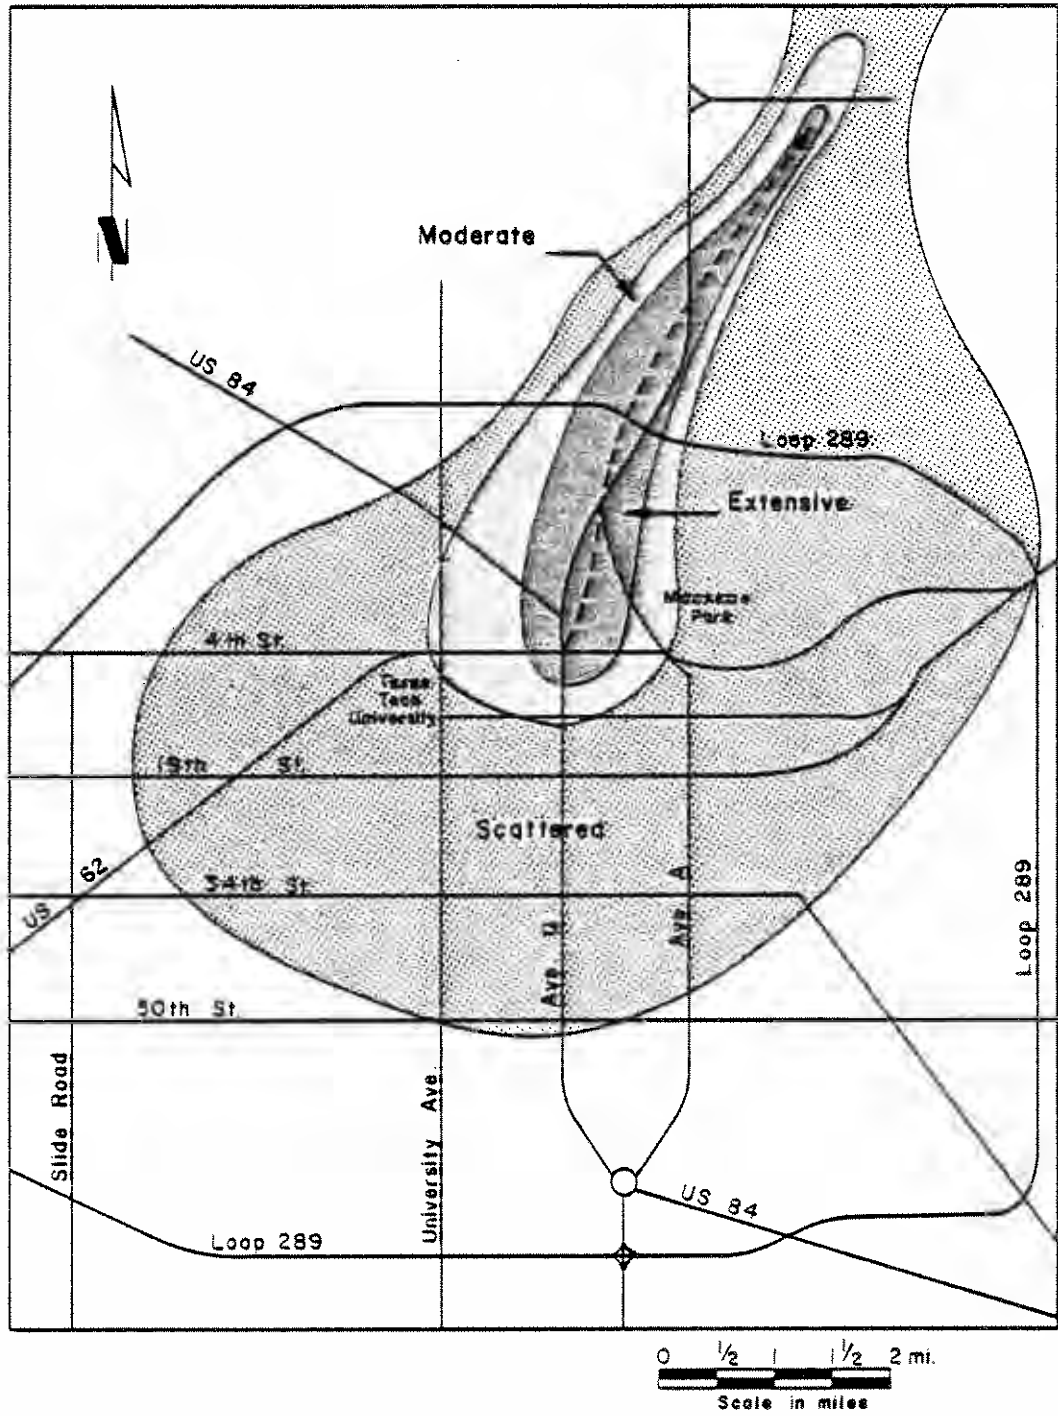
FIGURE 2. PATTERN OF DAMAGE CAUSED BY THE LUBBOCK STORM

damage to the structures was relatively light (damage to carport roofs, fences, shingles, metal roofing, and siding). It is important to note, that individual structures in each of the three destruction "zones" may have received degrees of damage different from that implied by the zone designation; specific structure damage designations are treated in Section III.

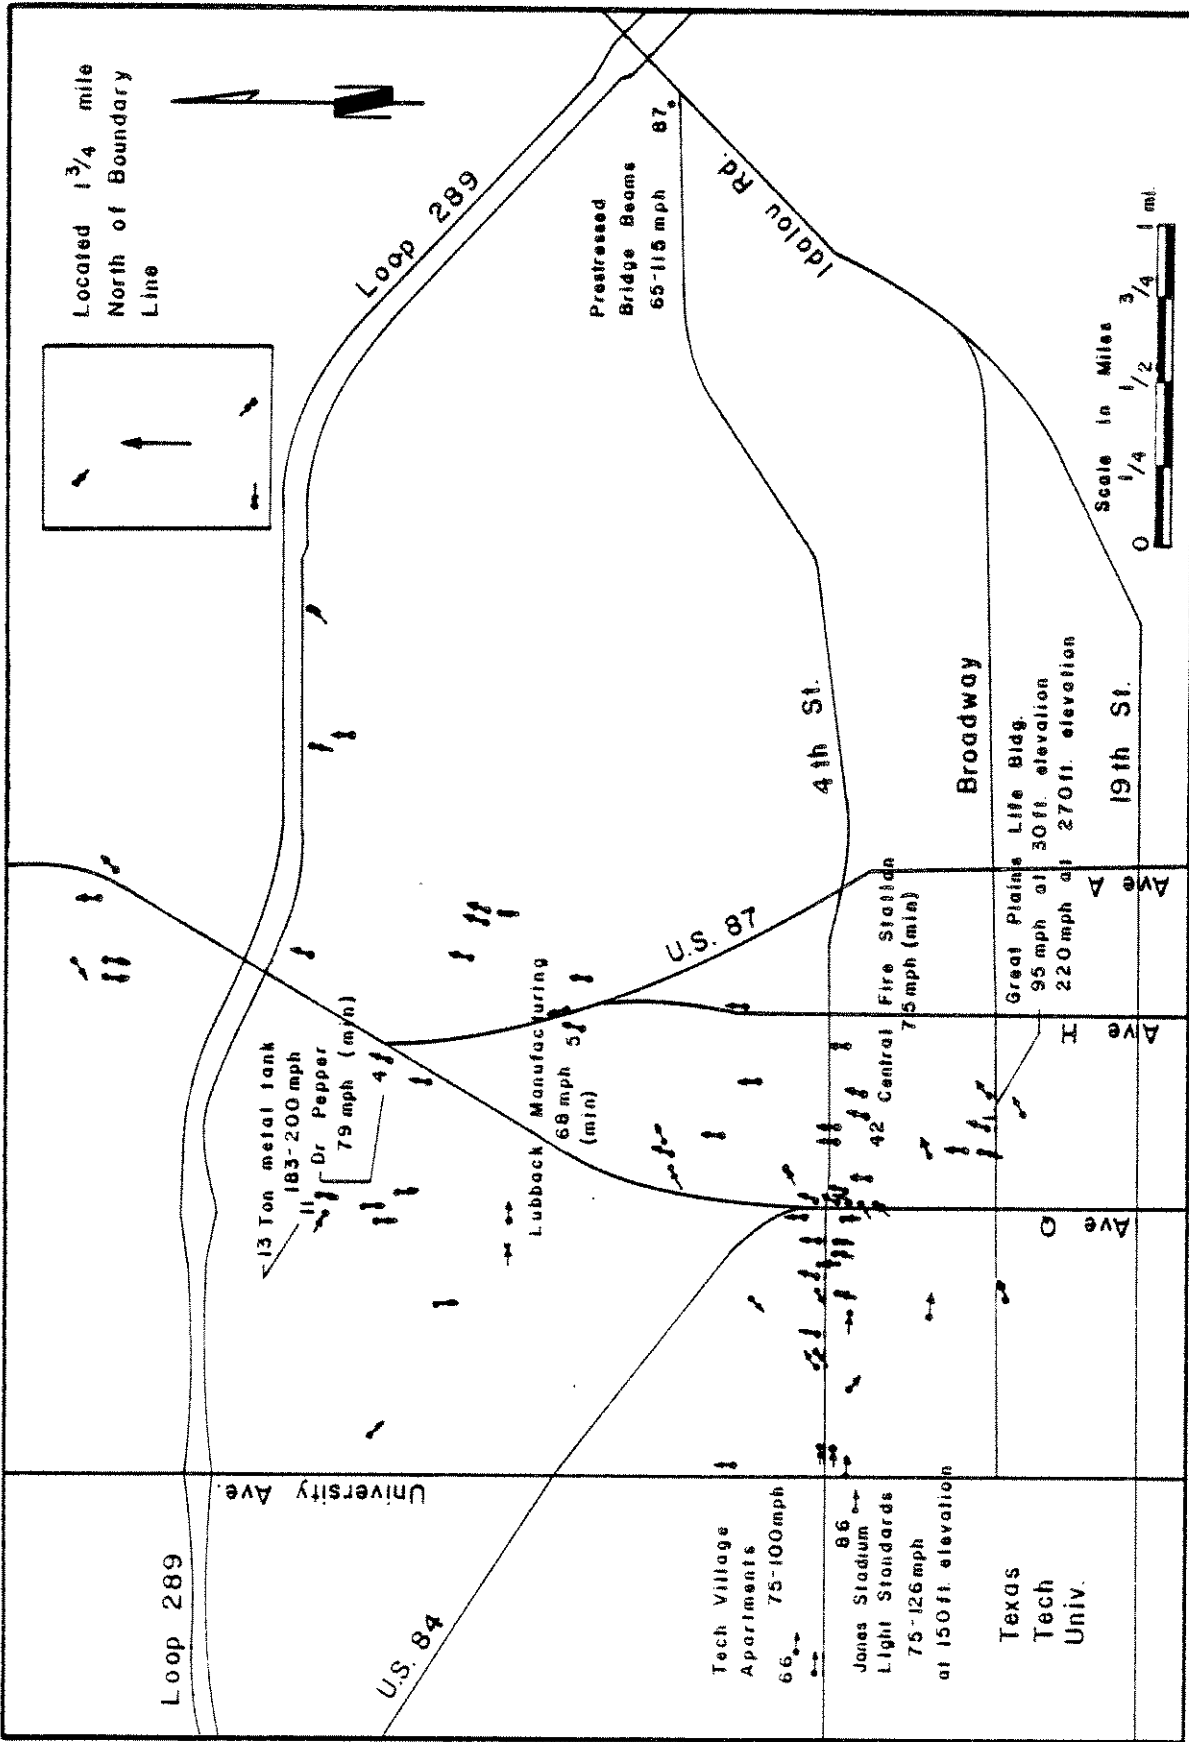
FIGURE 3. WIND DIRECTIONS AT NINETY THREE LOCATIONS WITHIN THE DAMAGED AREA

Ninety-three individual structures were examined in detail by teams of structural engineers and students assembled from the Department of Civil Engineering. Detailed documentations of damage to these structures comprise the major portion of this report. Each structure has been numbered for identification purposes and located on a map of the Lubbock area (see Section III). As additional background data, the wind directions determined by examining damage at each structure location have been noted by arrows on a map of the Lubbock region; this wind direction information is presented in Figure 3. In several specific damage situations, the nature of the structure and its orientation with respect to the wind (e.g. a sign or a light pole) permitted quantitative computations of wind velocities. The locations of these structures and the computed wind velocities are also noted in Figure 3. Except for these specific examples related to failures of relatively "clean"
