#### IV. WINDBORNE OBJECTS AND MISSILE DAMAGE

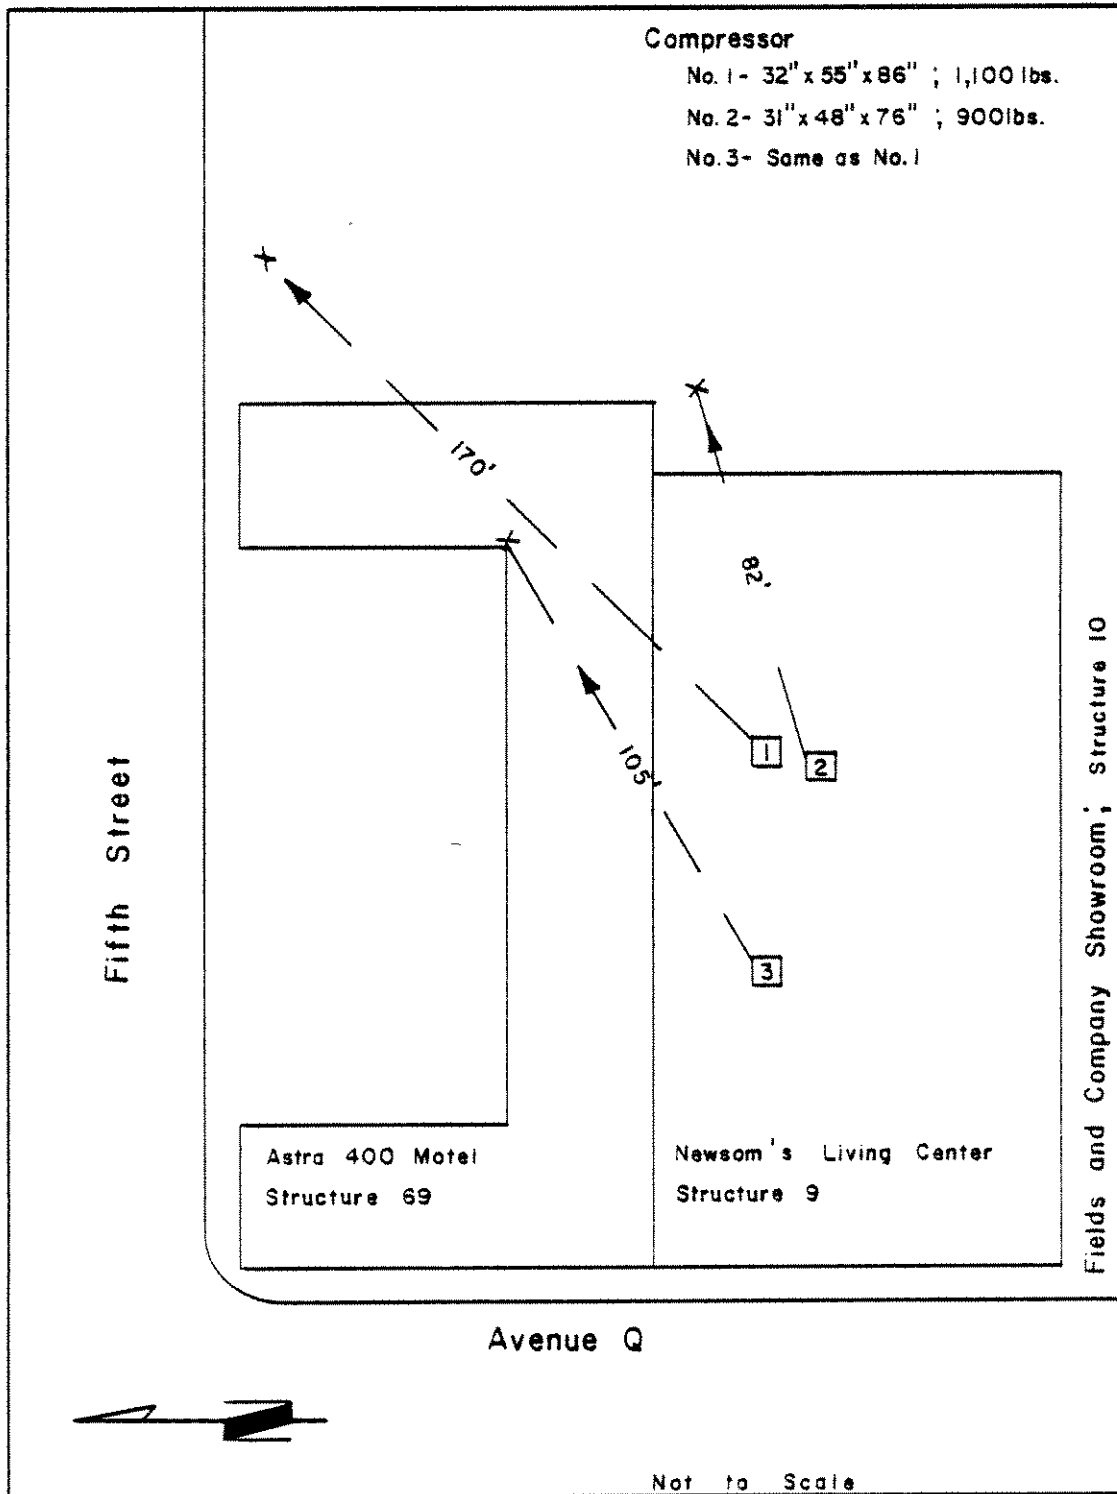
FIGURE 5. DATA AND PATHS OF TRAVEL OF INDUSTRIAL AIR CONDITIONING COMPRESSORS

Three air-conditioning compressors were located on the roof of Newsom's Living Center (Ref. Structure 9) prior to the storm. After the storm two compressors were found on the ground and the third compressor was found wrapped around a second floor column in the Astro 400 Motel (Ref. Structure 69). The paths of travel, the initial and final locations of the compressors, and compressor sizes are shown in Figure 5. The destroyed compressors are shown in Figure 6 (for compressor No. 1), Figure 7 (for compressor No. 2), and Figures 8 and 9 (for compressor No. 3).

The three compressors were located on the roof at an elevation of 18 ft. They travelled horizontal distances ranging from 82 to 170 ft. They probably rolled along a portion of the total distance travelled. It is noted, however, that compressor No. 1 (Ref. Fig. 6) virtually disintegrated, and compressor No. 3 (Ref. Figs. 8 and 9) wrapped itself around a steel column in the adjacent structure. The types of damage sustained by the compressors indicated that they moved with significant velocities during the storm.

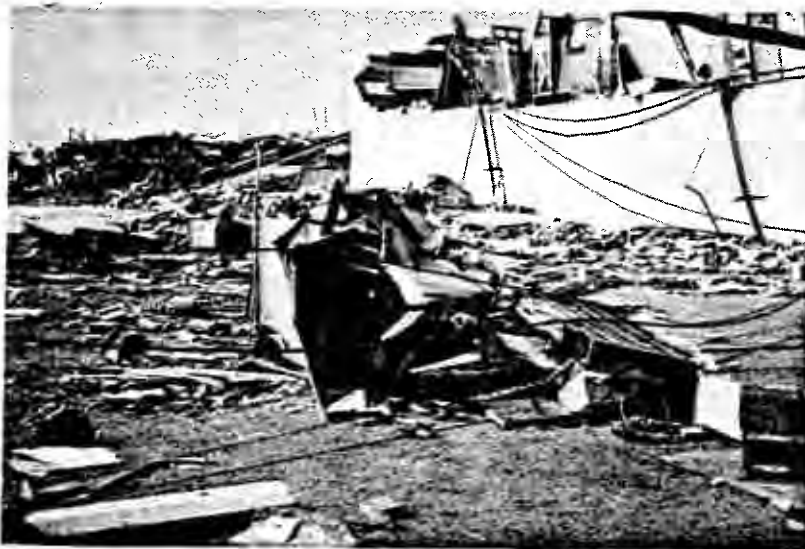
FIGURE 6. VIEW OF DESTROYED COMPRESSOR NO. 1

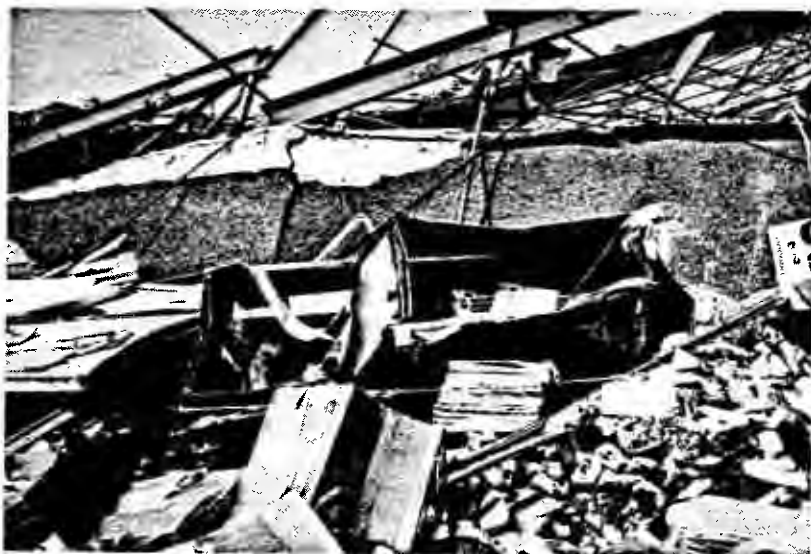
FIGURE 7. VIEW OF DESTROYED COMPRESSOR NO. 2

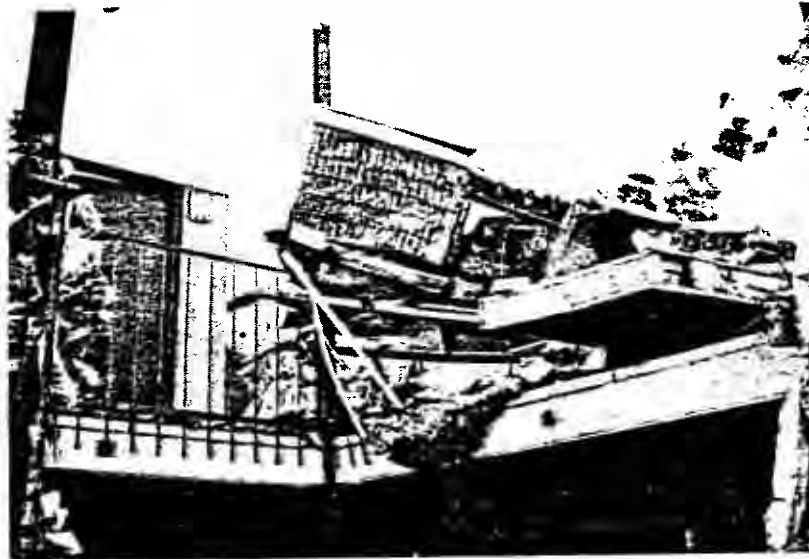
FIGURE 8. VIEW OF COMPRESSOR NO. 3 WHICH WRAPPED AROUND STEEL COLUMN

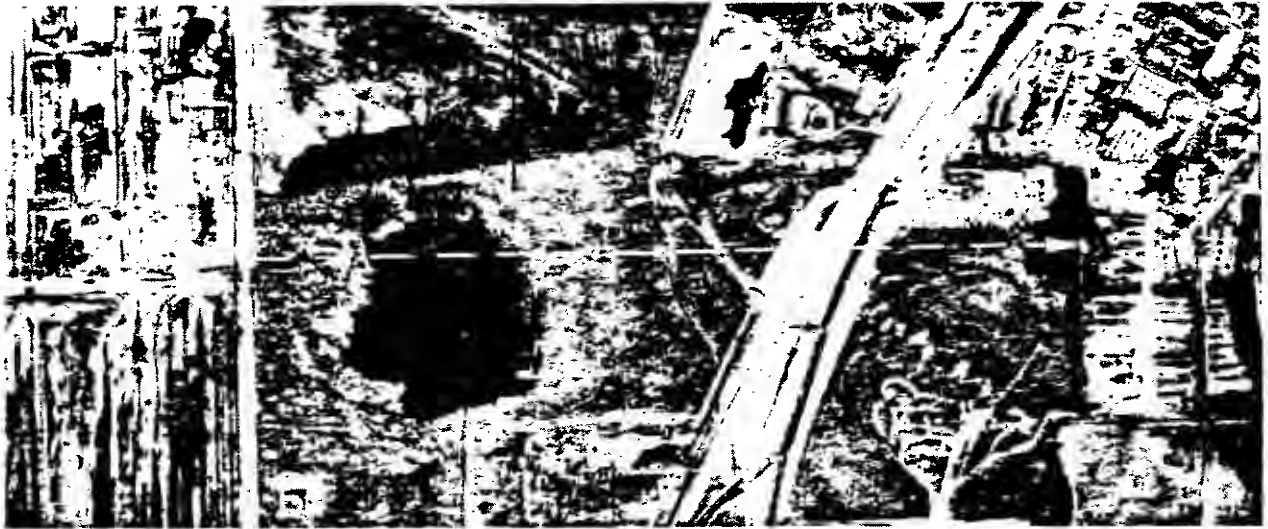
FIGURE 10. AERIAL PHOTOGRAPH SHOWING ORIGINAL AND FINAL LOCATIONS OF 13-TON FERTILIZER TANK

An 11 ft diameter by 41 ft long cylindrical metal tank weighing 25,800 lbs was found approximately 3/4 mi east of its original location. It travelled from Goodpasture Grain Storage Complex (Ref. Structure 11) to Clark Manufacturing Company (Ref. Structure 7). An aerial photograph in Figure 10 taken from 3000 ft elevation shows the original location, path of travel, and final location of the tank. The tank is shown in Figure 11 after it was brought back to its original location. The fertilizer storage tank was empty on the day of the storm.

The tank sits on four steel saddles (Ref. Fig. 11) and is restrained only by its own weight. It sits 2-1/2 ft above the ground. The longitudinal axis of the tank is oriented east-west. Turbulent winds pushed it off of its saddle supports and moved it 3/4 mi to the southeast corner of the Clark Manufacturing Company property (Ref. Structure 7). It has not been determined whether the tank rolled throughout this distance, or was airborne part of the way. During the 3/4 mi of travel the tank rotated from an east-west orientation to a north-south orientation, and crossed a four-lane highway and an access road. It apparently passed between two motels in the area since there was no known damage to these structures induced by the tank. The terrain along the the travel path of the tank is reasonably flat and there are no sharp depressions. The water pond which can be seen as a dark area in Figure 10 was probably formed during the rain that followed the wind storm.

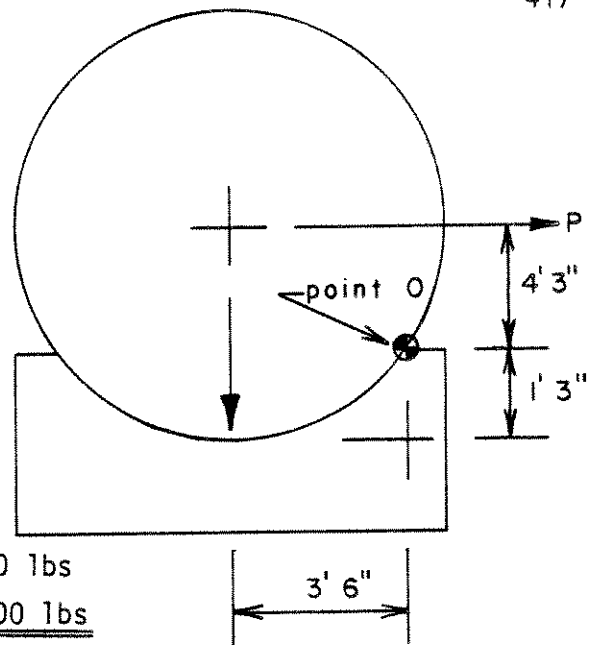
FIGURE 12. WIND VELOCITY CALCULATIONS FOR  
13 TON FERTILIZER TANK

The wind velocity necessary to push the tank from its saddle supports has been calculated to be 183 mph. This calculation assumes that the wind acted uniformly on the side of the tank and that the drag coefficient for the cylindrical tank is 0.55. Wind velocity calculations are contained in Figure 12.

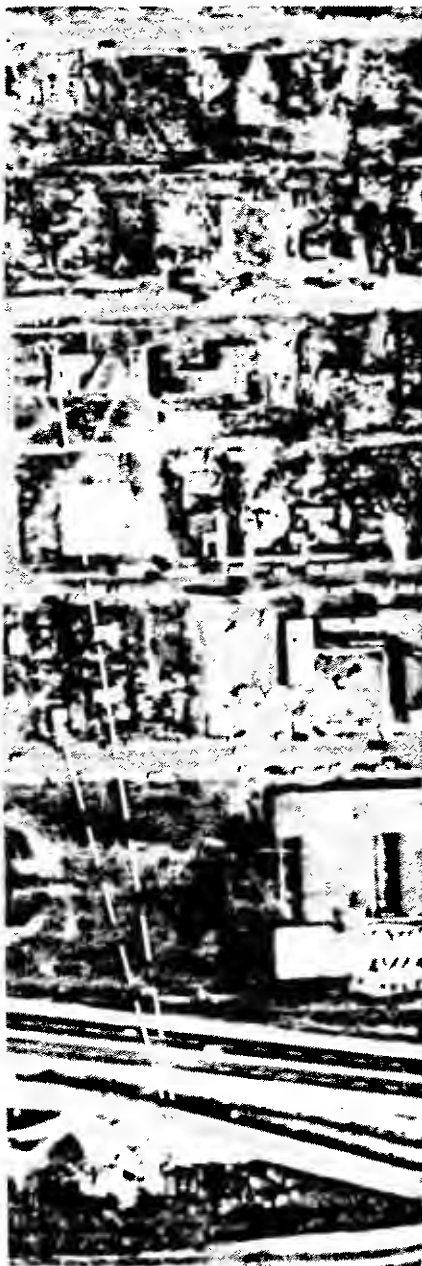
FIGURE 13. AERIAL PHOTOGRAPH SHOWING ORIGINAL AND FINAL LOCATIONS OF THE TANKS

Three metal tanks were pushed across a highway by the wind. Two of these tanks crashed into the Catholic Welfare Center (Ref. Structure 24) causing considerable damage. One tank was 5 ft in diameter x 10 ft long while the other two tanks were smaller: 3 ft in diameter x 10 ft long. The tanks were old and were probably used for storing used oil. The original locations, paths of travel, and final locations of the tanks are shown in Figure 13. This aerial photograph was taken from an elevation of 3000 ft.

All three tanks travelled across an access road and a four-lane highway, and crashed through a chain-link fence that was barricading the highway. The direction of travel of all of the tanks was due east. The terrain in the area was flat, and most of the distance travelled was over open grounds.

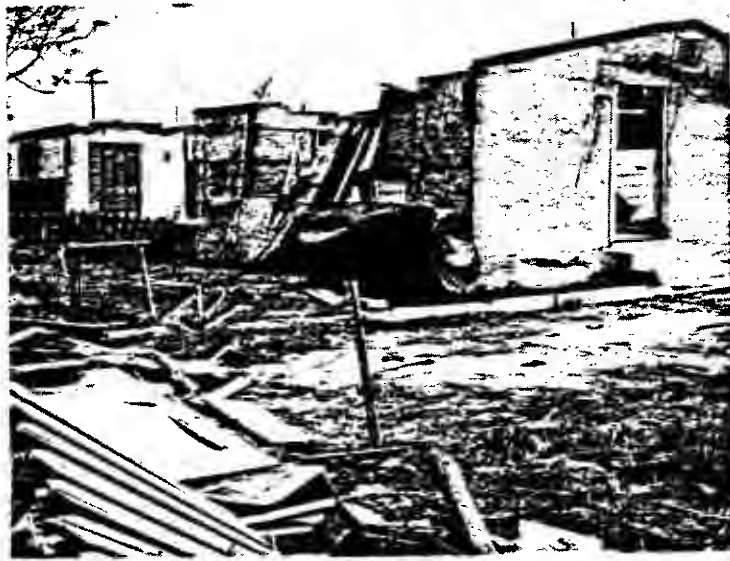
Tank No. 1, which was of the smaller size, travelled approximately 600 ft and stopped in front of a residence, as shown in Figure 14. The broken chain-link fence in front of the residence indicated that the tank rolled into the front yard from the street. The tank itself was damaged; however, it did not cause damage to the residential structure.

FIGURE 14. TANK NO. 1 IN FRONT OF A RESIDENCE

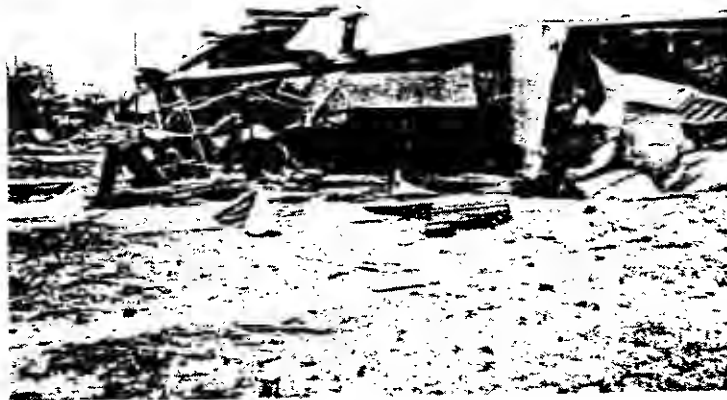
Tank No. 2 (3 x 10 ft) and Tank No. 3 (5 x 10 ft) travelled approximately 1000 ft and crashed into the Catholic Welfare Center. The damage created by these tanks is visible in Figure 15. The tanks are shown inside the structure in Figures 16 and 17. The hole in the roof of the structure indicated that Tank No. 2 may have been airborne when it entered the structure (Ref. Figs. 15 and 24.1). Tank No. 3 apparently rolled into the structure, breaking the siding and girt comprising the wall. Both of these tanks caused severe impact damage to the structure.

FIGURE 15. VIEW OF DAMAGE TO CATHOLIC WELFARE CENTER  
(STRUCTURE 24)

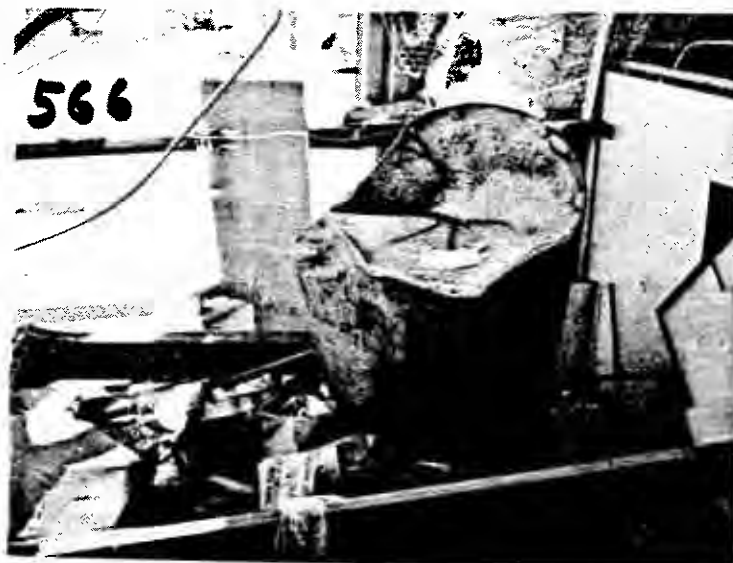
FIGURE 16. VIEW OF TANK NO. 2 INSIDE STRUCTURE 24

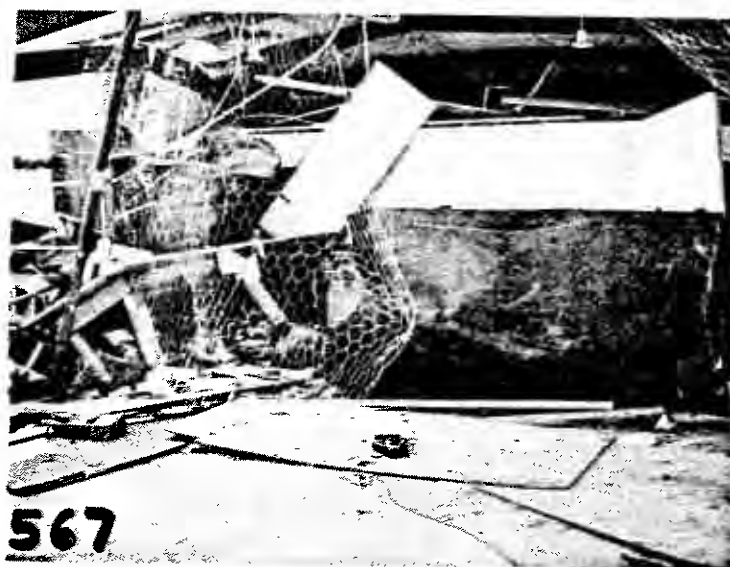
FIGURE 17. VIEW OF TANK NO. 3 INSIDE STRUCTURE 24

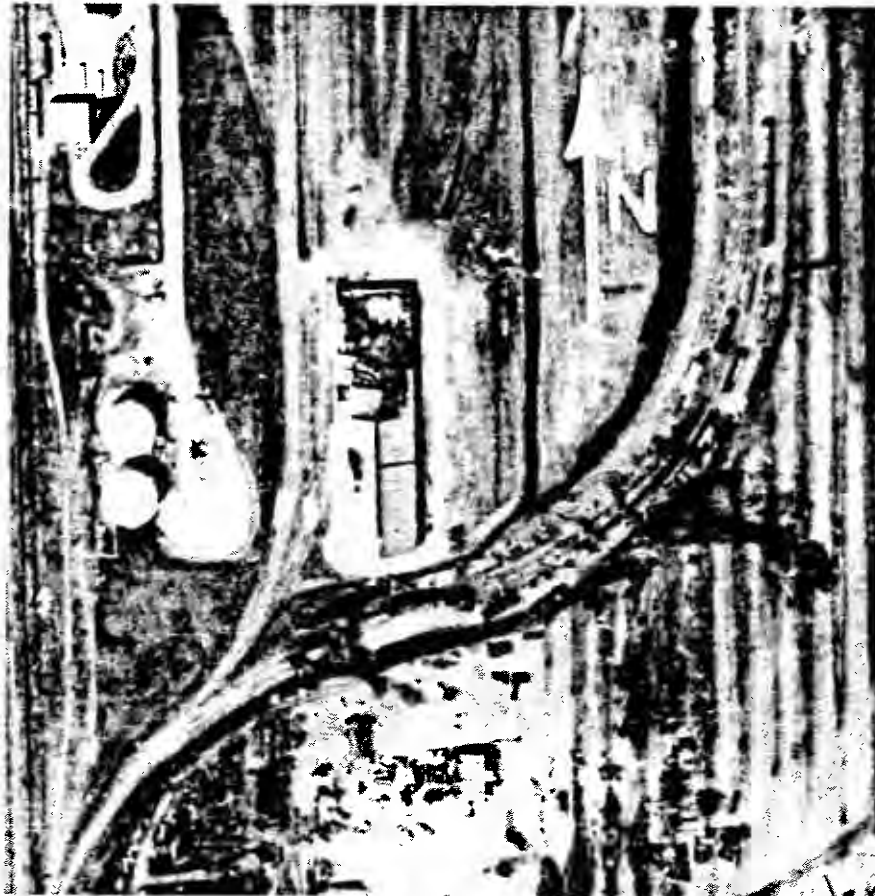
An aerial photograph presented as Figure 18 (taken from an elevation of 3000 ft) shows some of the overturned railroad cars. At the time this aerial picture was taken several of the overturned cars and the two cars that were found 175 ft away had been put back on the tracks. Disturbed soil produced by the movement of heavy equipment can be seen in Figure 18.

FIGURE 18. AN AERIAL PHOTOGRAPH SHOWING OVERTURNED RAILROAD CARS

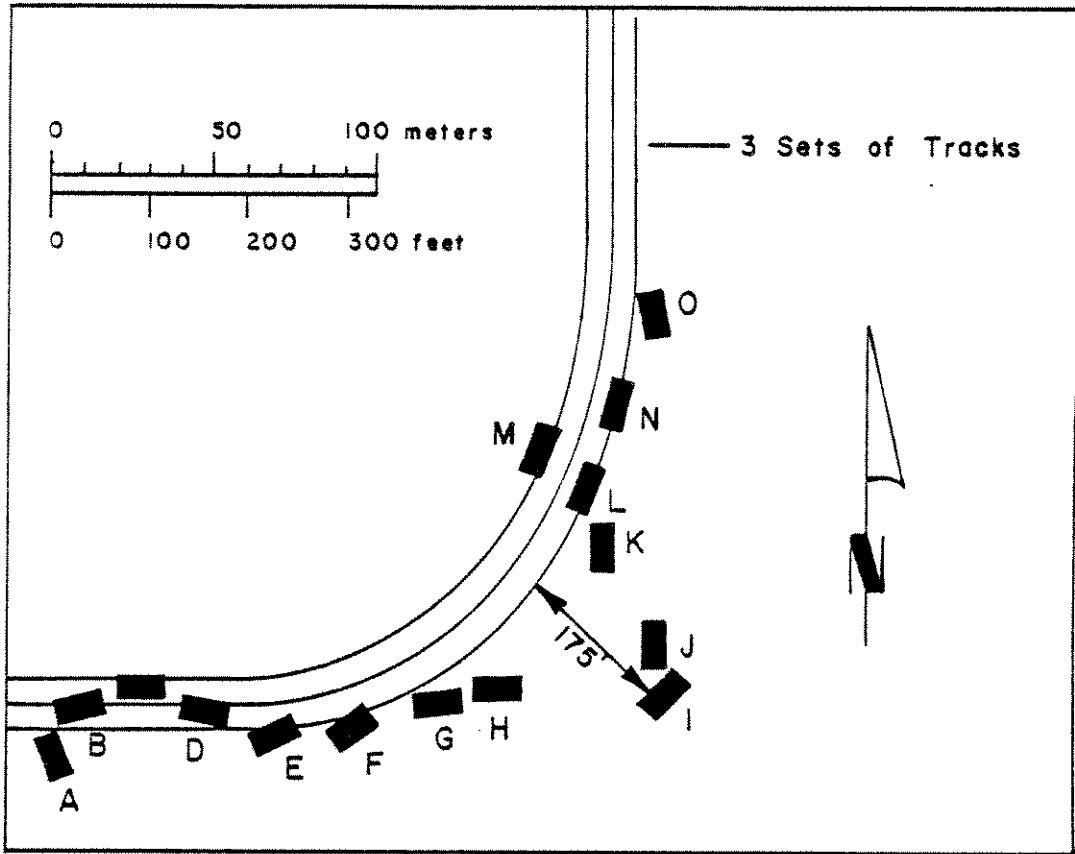
FIGURE 19. LOCATION OF 15 RAILROAD CARS  
SUBSEQUENT TO LUBBOCK STORM

The location of the cars immediately after the storm are shown in Figure 19. The types of railroad cars, their serial numbers, and their nominal weights are given in Table IV. It is noteworthy that all cars which overturned or rolled over were empty. The two cars designated L and N (Ref. Fig. 19) that were filled and the car designated C that was empty did not overturn.
